Portage Creek Sediment Remediation Project Kalamazoo, Michigan

Pre-Sediment Removal Structure Feature Assessment Removal Area SA6

F&V Project Number: 809930
April, 2012

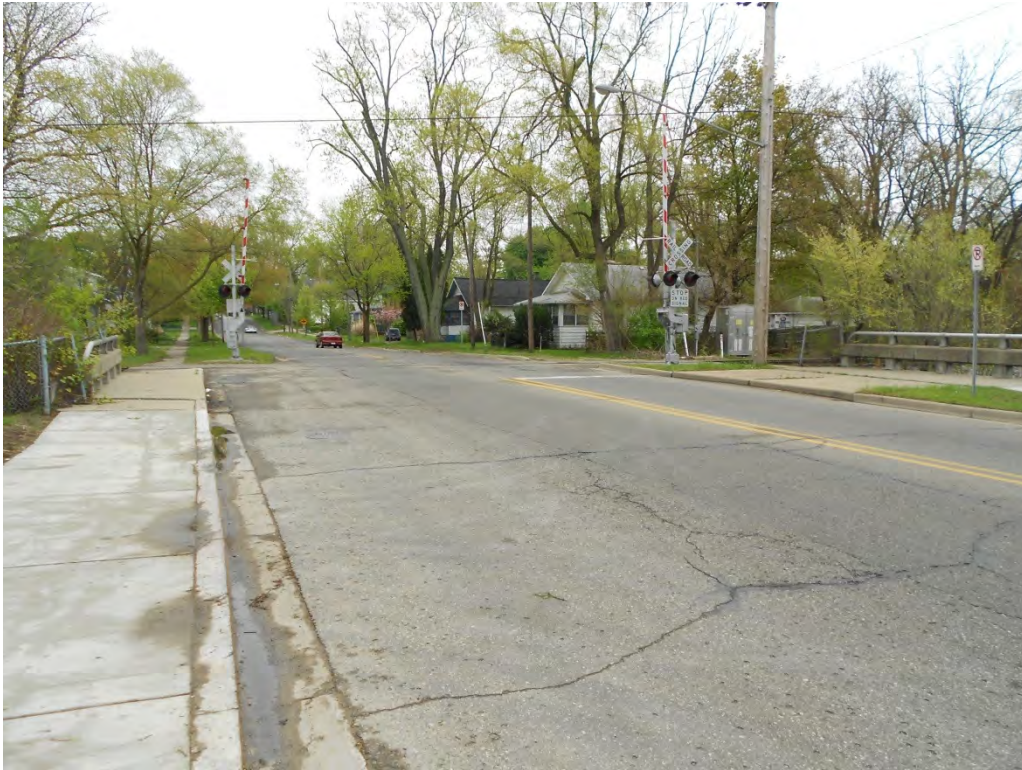
Structure viewed from northwest approach area

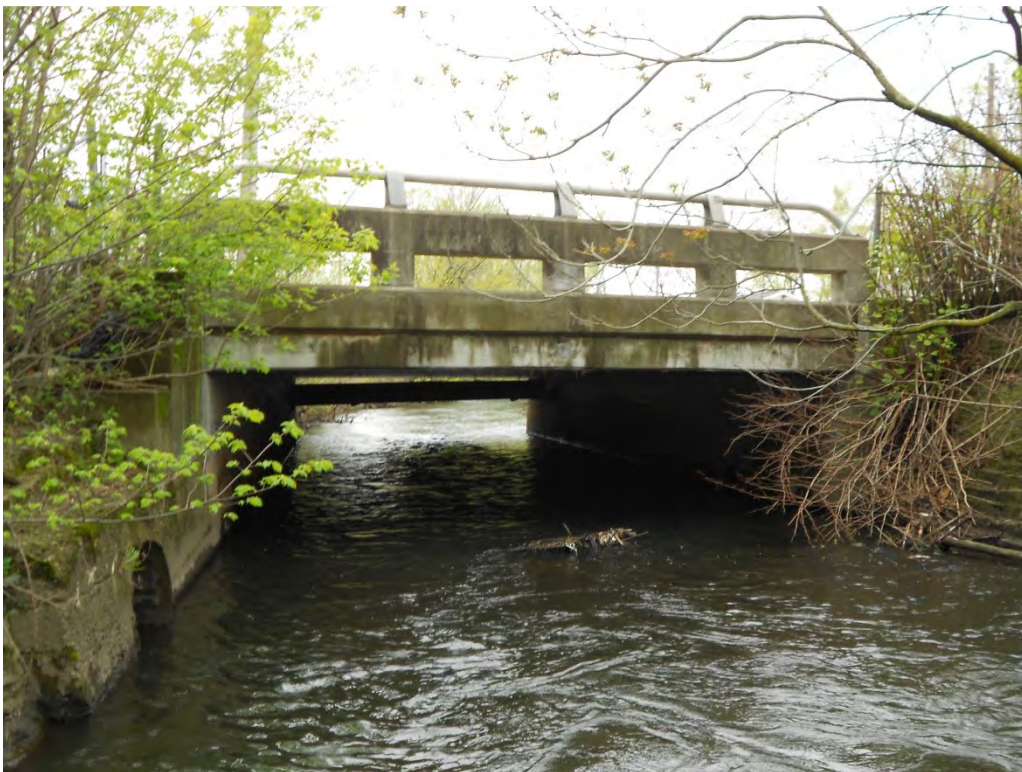
Elevation view of structure

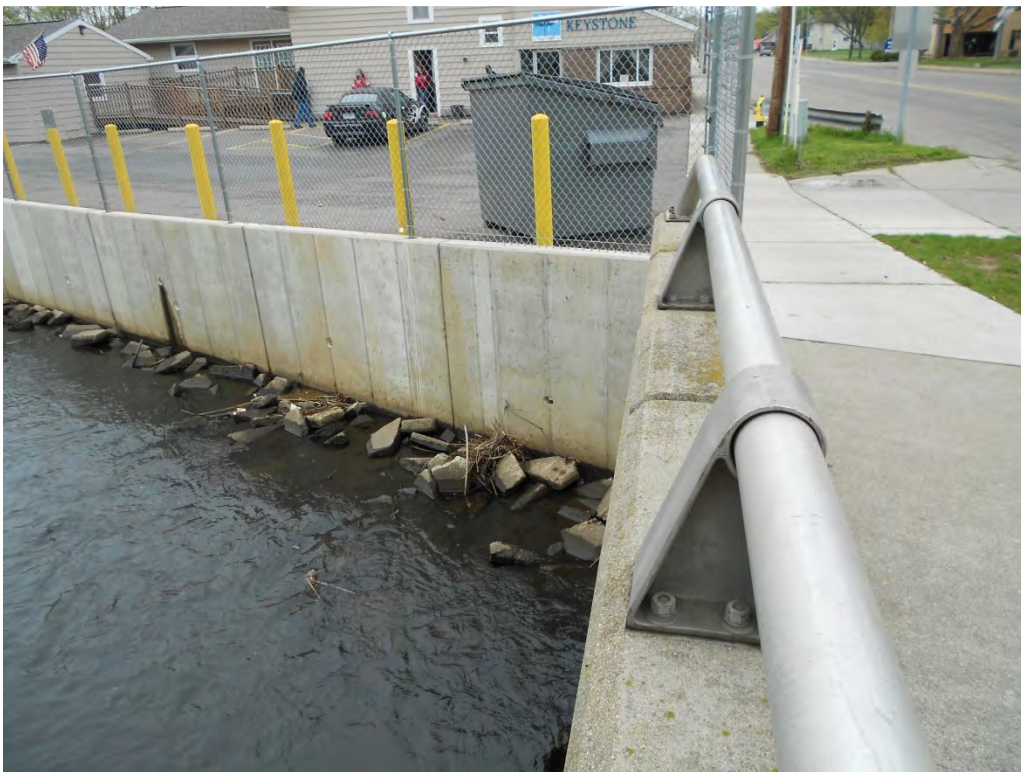
- The concrete parapet railing has sustained collision damage in the northeast.
- There is a newer concrete retaining wall supporting the southwest slope. The southeast slope is supported by a concrete block type wall with moderate to severe vertical cracking and minor erosion around the end. The northeast has a smaller concrete block type wingwall extension with separation of the vertical joint. The northwest has a concrete block type wall which is overgrown, has minor vertical/step cracking and end is undermined ~12-18".

Newer retaining wall and riprap in the southwest

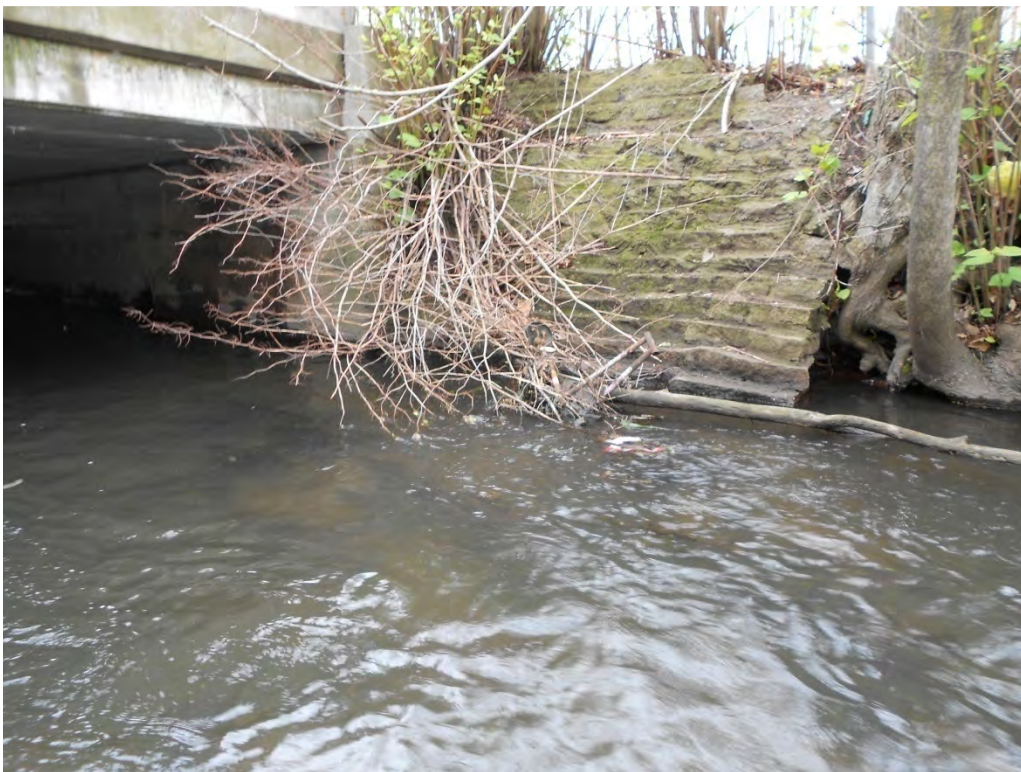
Overgrown wingwall extension in the northwest

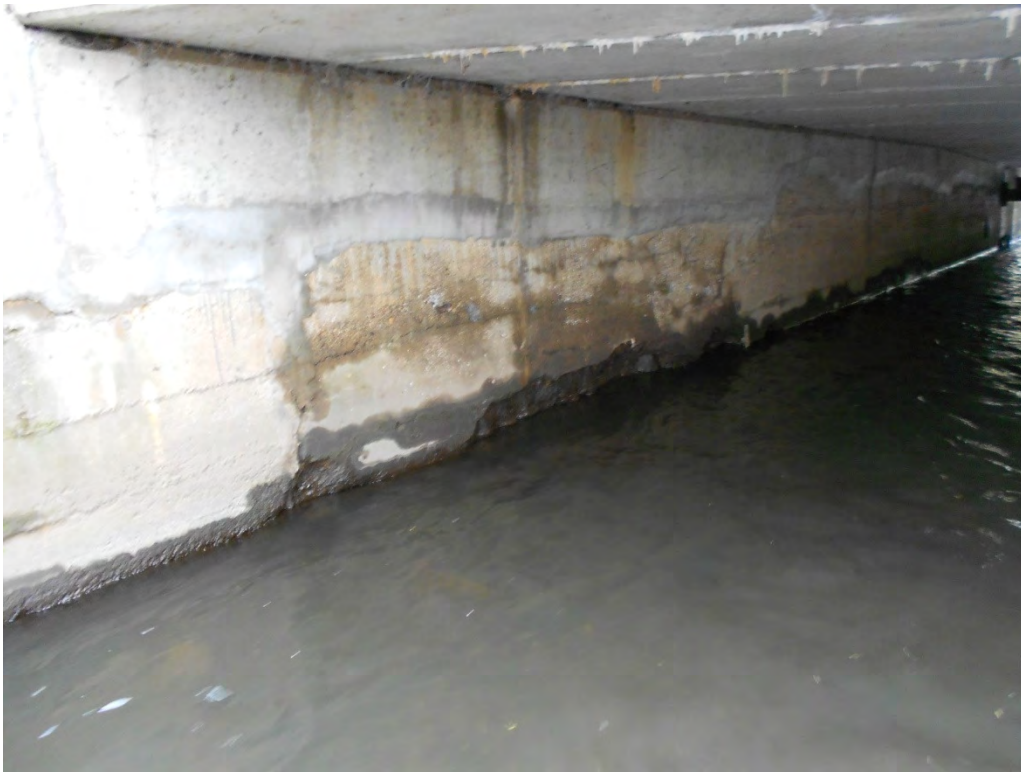
- The northeast abutment is severely spalled and abraded at the waterline. The abutments have moderate abrasion along the waterline throughout.
- Heavy leakage with efflorescence and stalactites was noted on box beam joints 1N, 2N and 1-5S.

Spalling and abrasion along northeast waterline

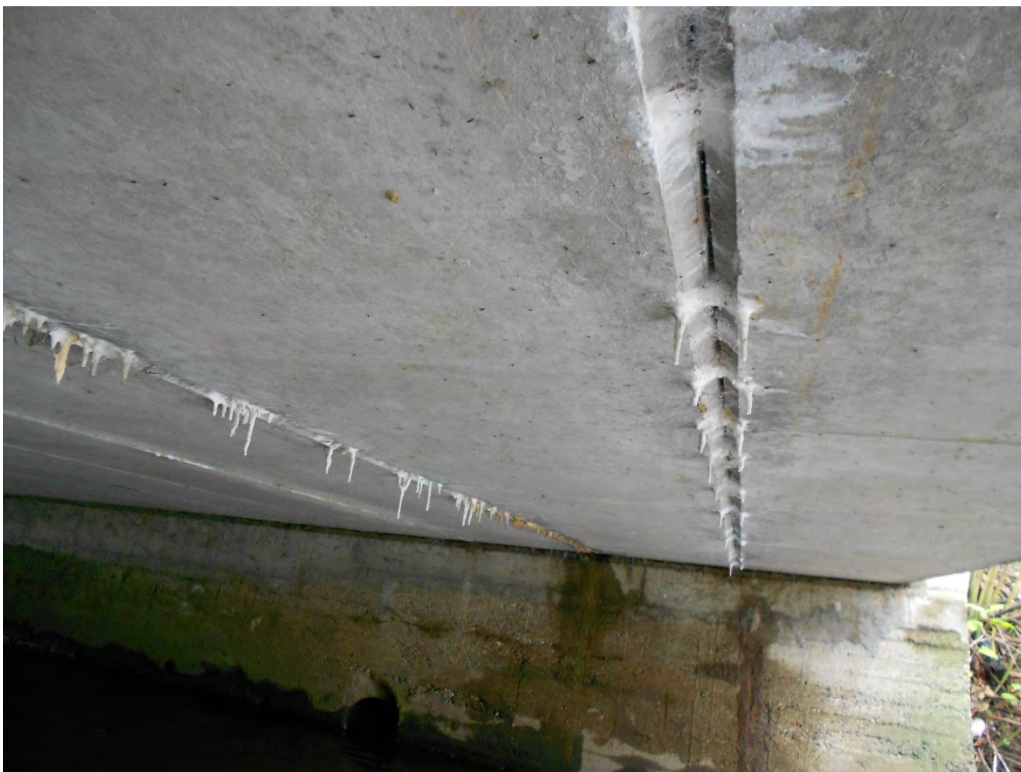
Efflorescence and stalactites along box beam joints

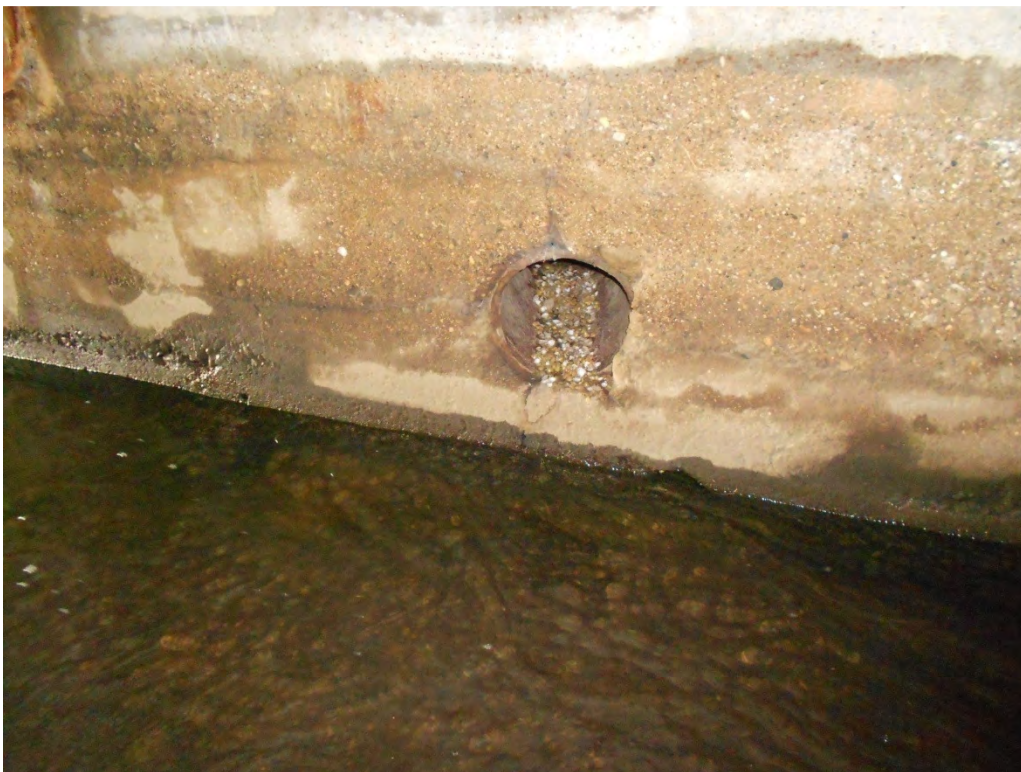
- There are culvert outlets through the northwest, southwest and southeast (2) abutment areas and northeast wingwall extension. There is a scour hole 1-2' deep around the northeast outlet.

Culvert outlet through abutment above waterline

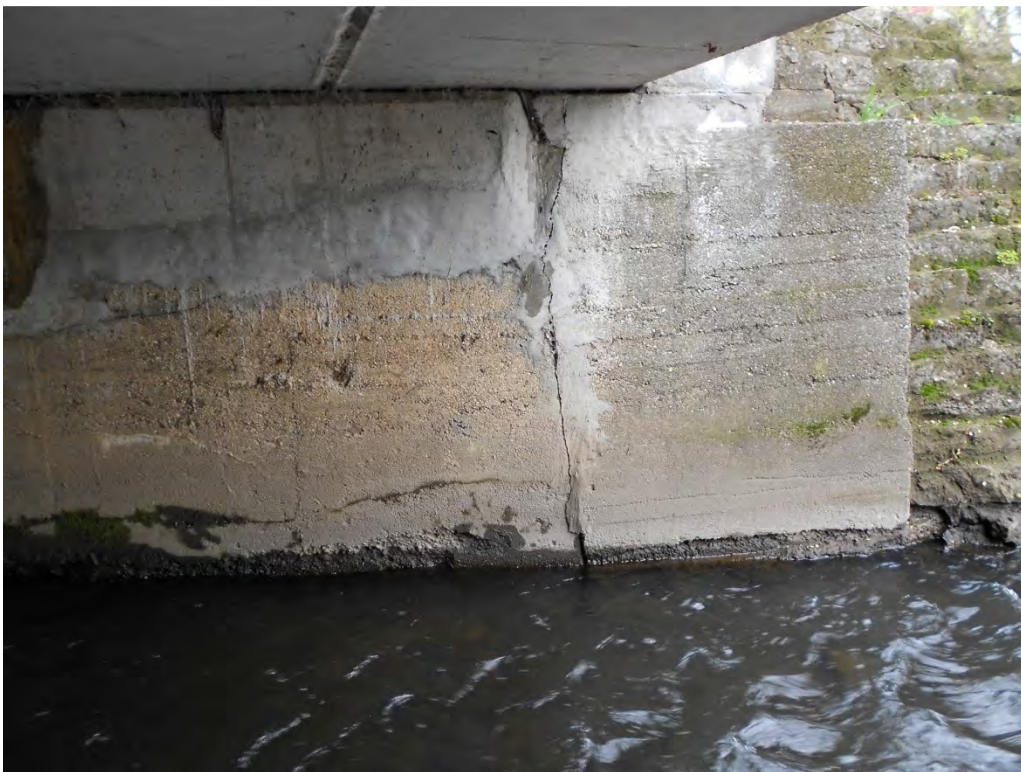
- There is a moderate vertical crack in the southeast abutment and diagonal crack in the southwest. There is a minor vertical crack near the centerline of the east abutment.

Vertical cracking in abutment

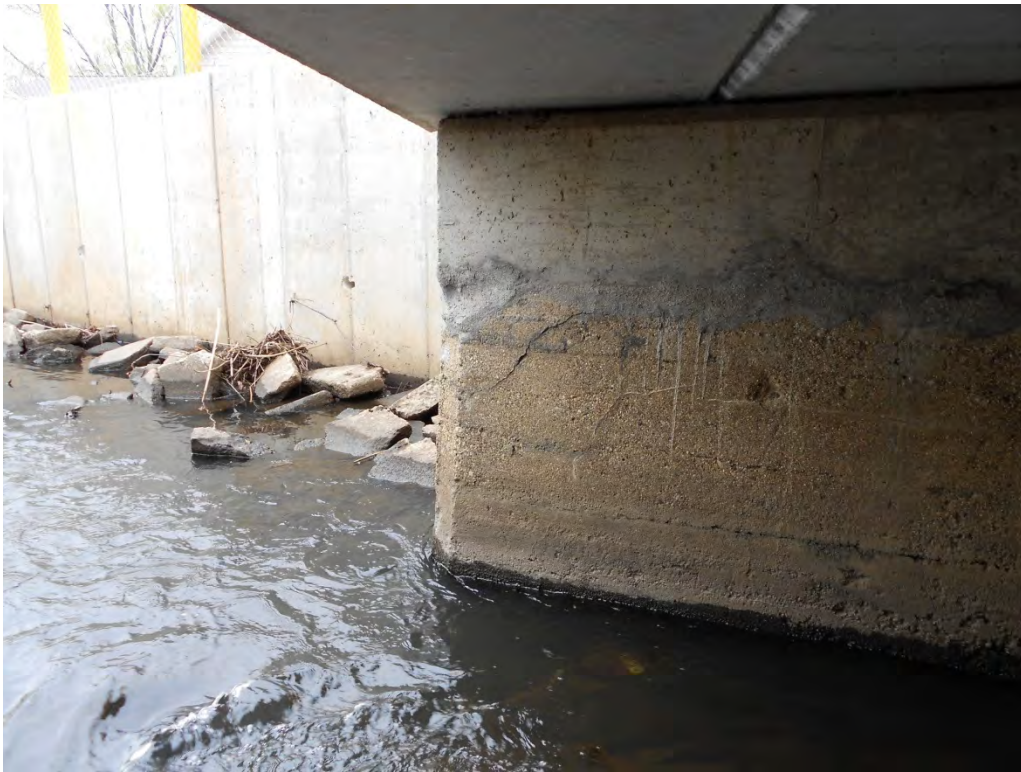
Diagonal cracking in southwest abutment

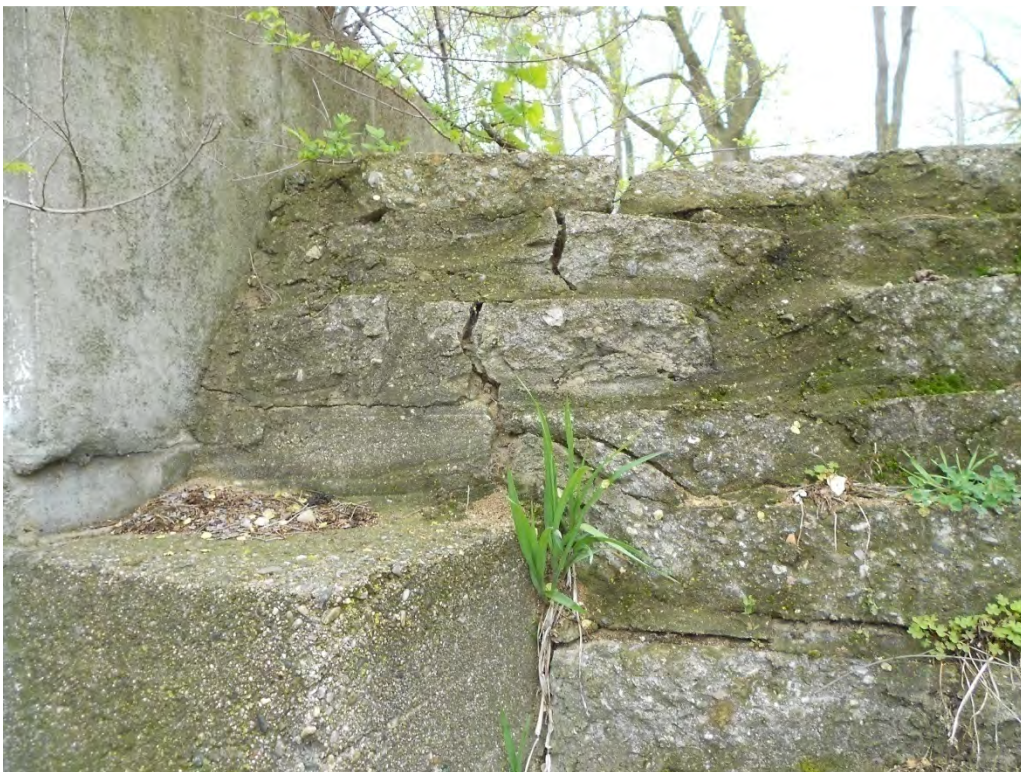
Cracking in concrete block wingwall extension

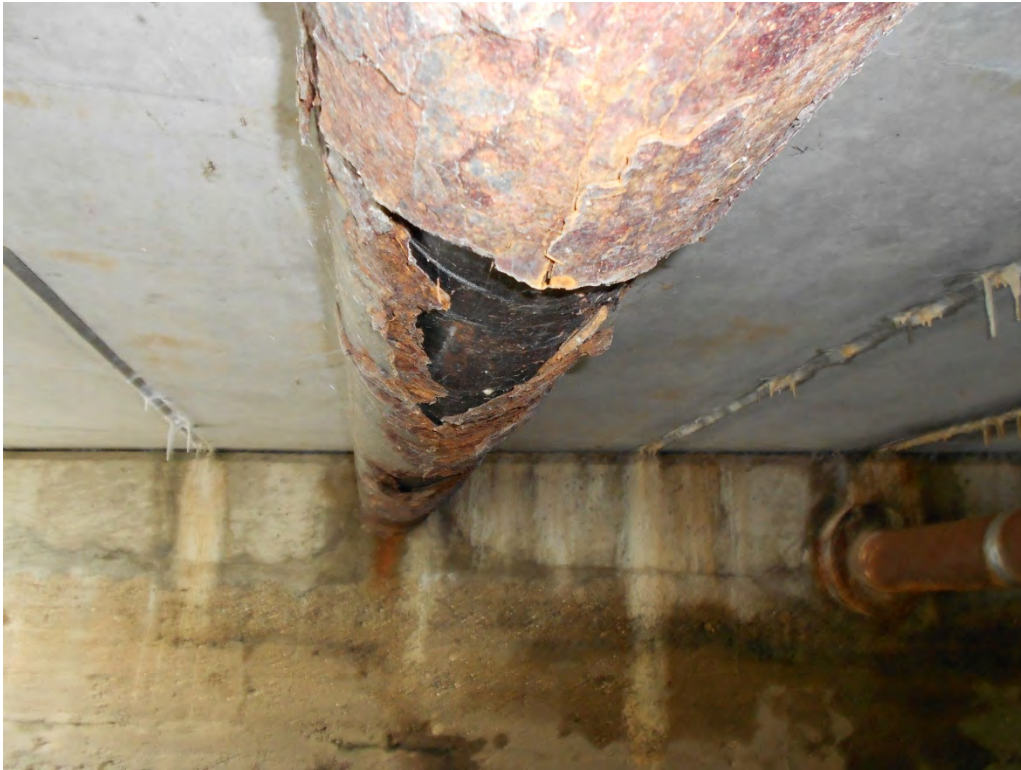
- There are 2 utilities crossing the creek beneath the south side of the structure through the abutment walls. The northern pipe has moderate surface corrosion. The southern pipe has heavy surface corrosion and scale with minor to moderate section loss, especially on the bottom.

Severe corrosion and section loss on bottom of utility pipe

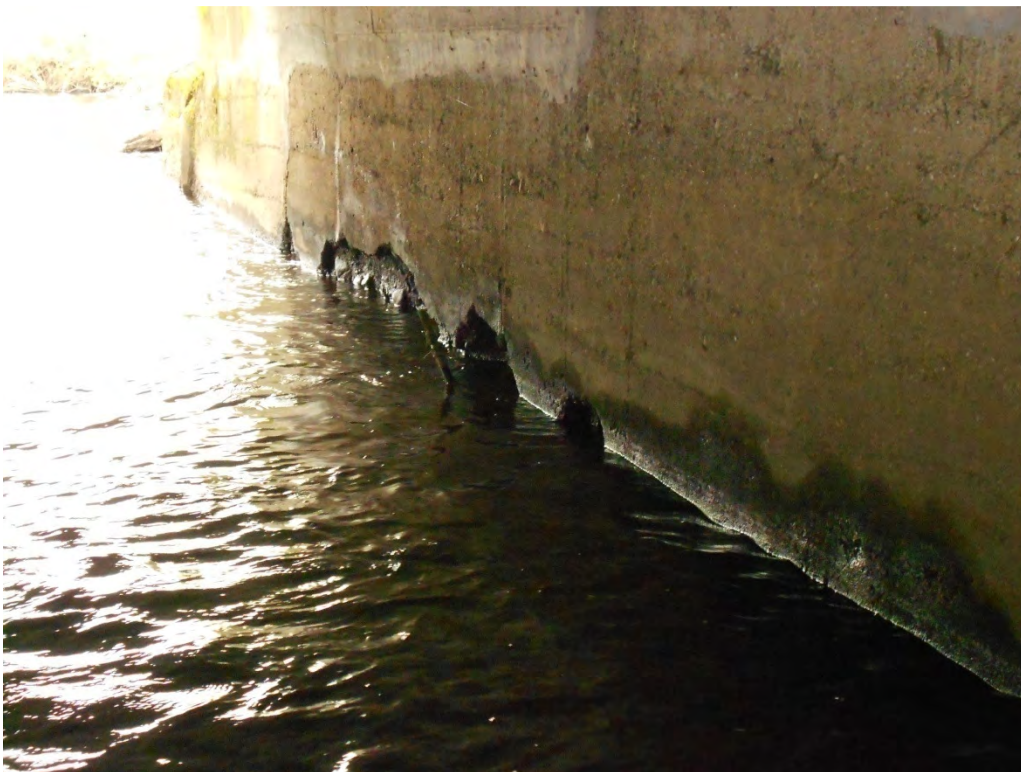
Spalling and abrasion along northeast waterline

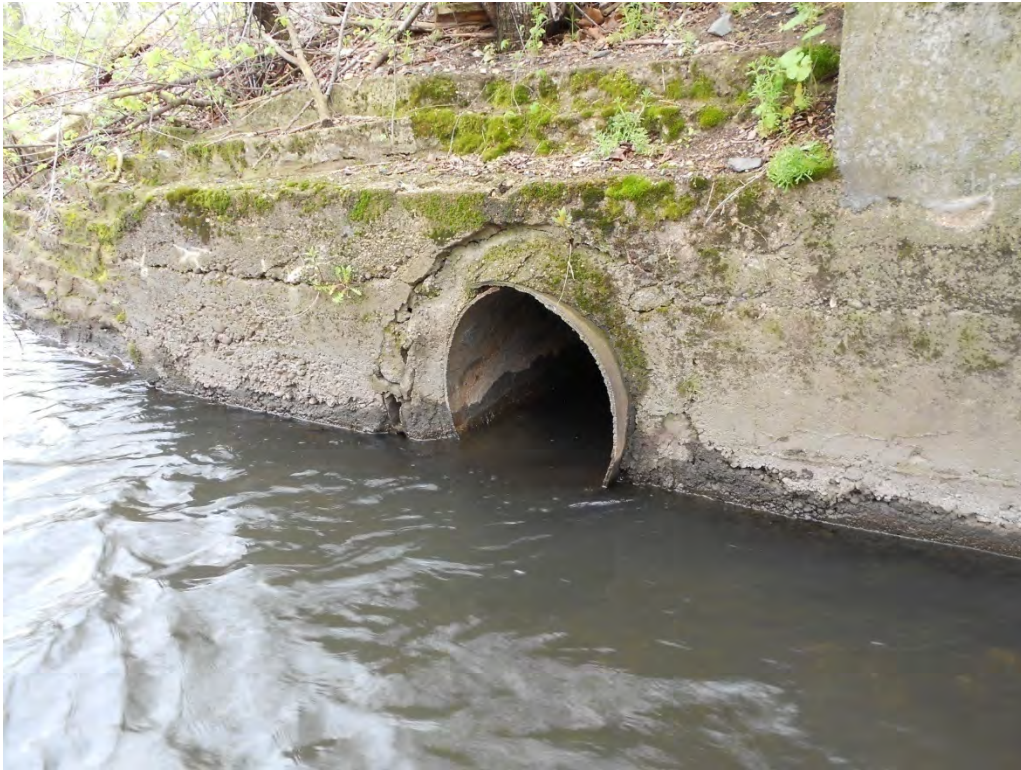
Culvert outlet through northeast wingwall

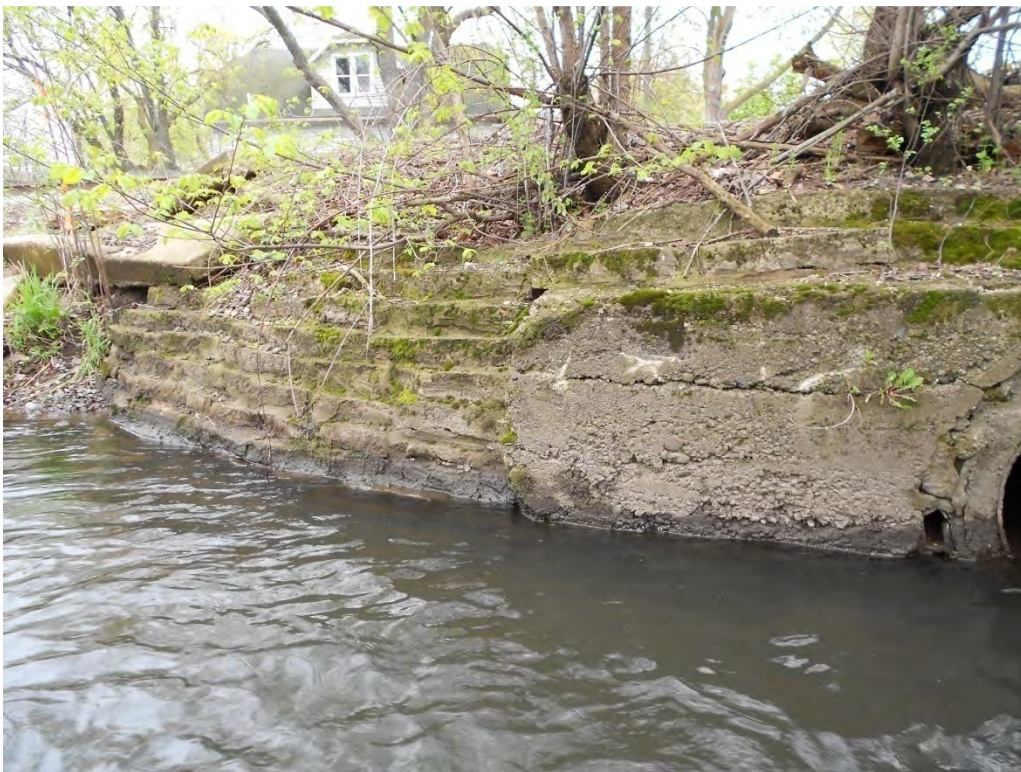
Northeast wingwall extension

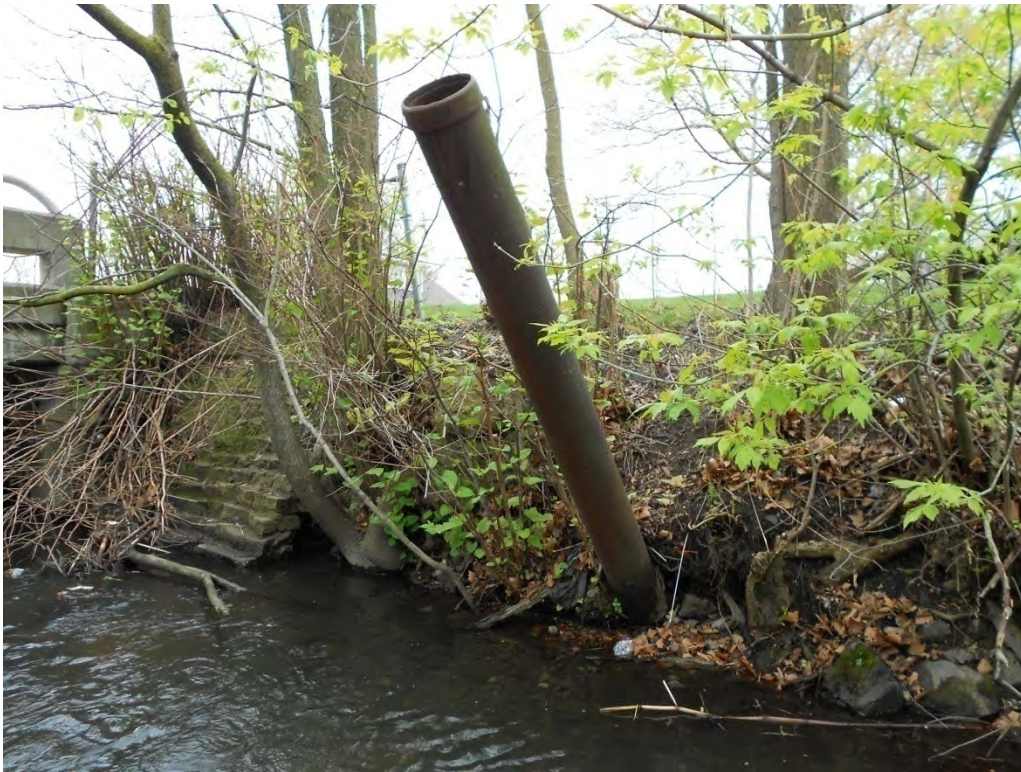
Overall view of the structure from the channel

- It may be possible to remove the structure if its purpose can be established. However, the structure is located far enough south of the southernmost cofferdam limits that the sediment removal work should not impact it. Therefore, no special protective measures should be required.

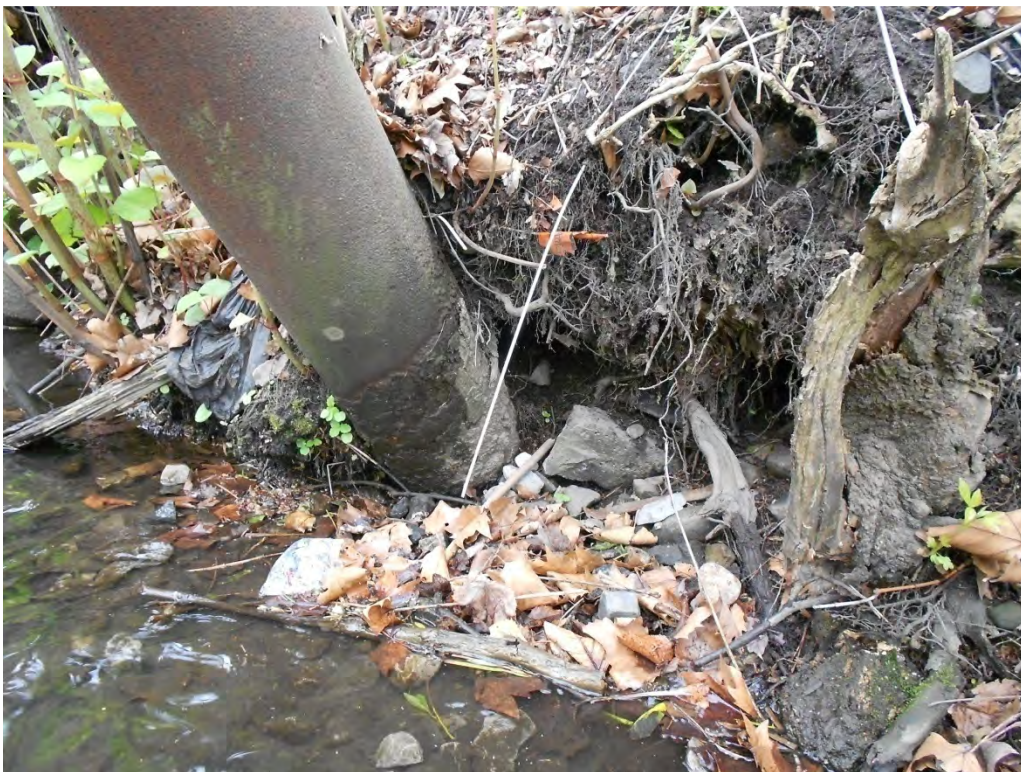
- The pipe has moderate surface corrosion and pitting with heavy scale at the waterline.
- There is severe bank erosion around the pipe, approximately 18-24 inches deep.

Heavy scaling and bank undermining at the base of the structure

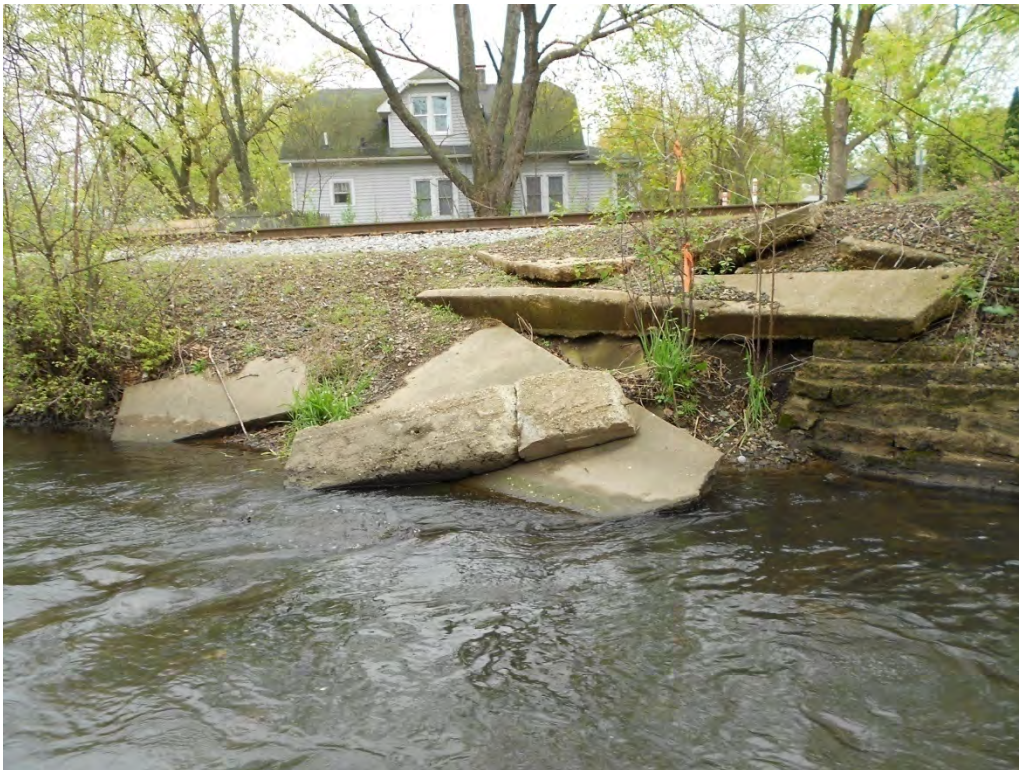
- Several of the slabs are cracked and spalled.
- Most of the slabs are undermined to some degree.

Overall view of the structure with the railroad tracks in the background

- Remove the slabs as needed to facilitate sediment removal and replace them in kind as directed by the City of Kalamazoo.

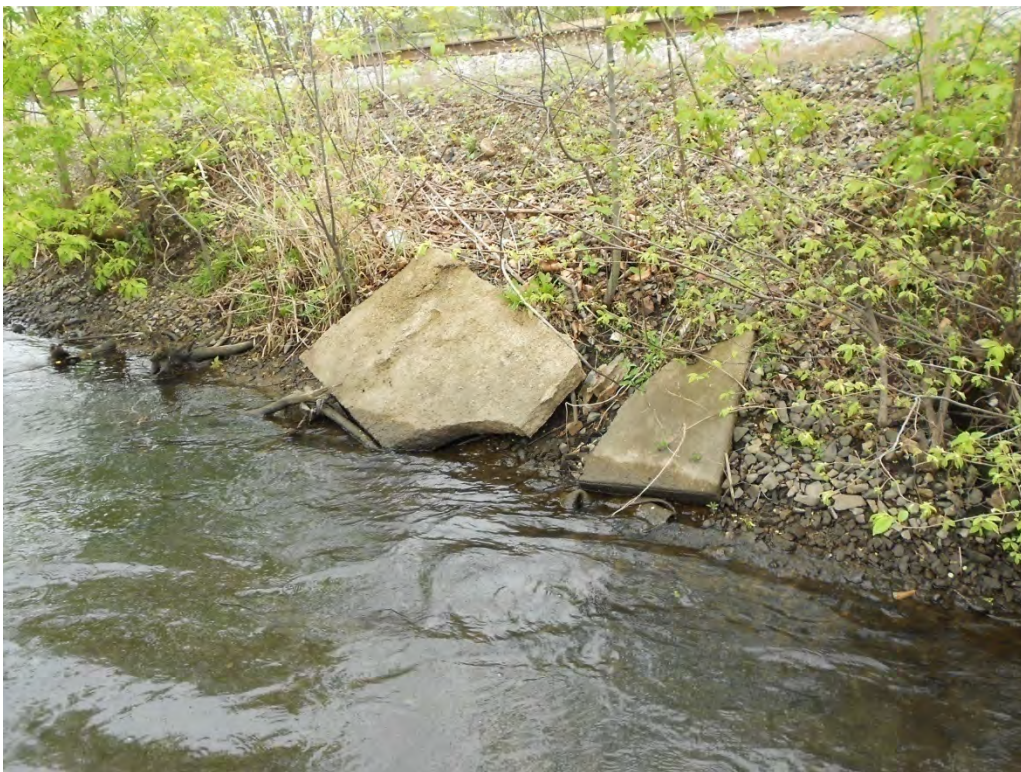
Northernmost slabs in the area

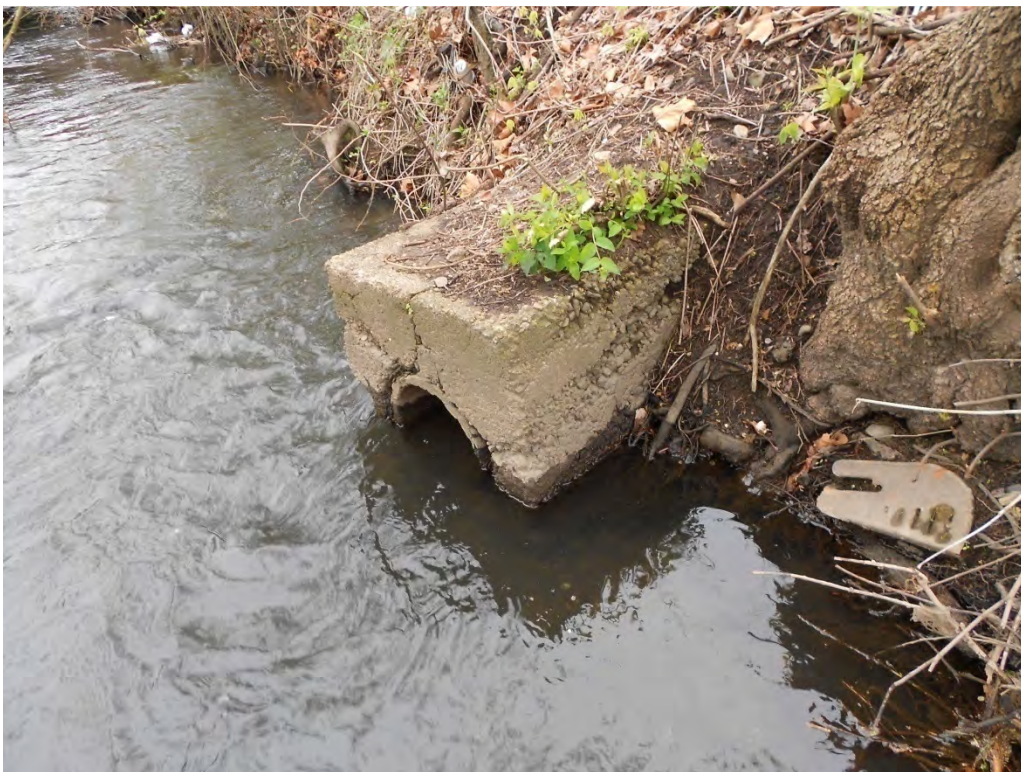
- The concrete headwall is severely abraded and cracked. The upstream lower corner has spalled off.
- The exposed end of the clay tile is spalled.
- The channel is approximately 8 inches below the invert of the pipe, but no undermining was noted.
- The bank has eroded approximately 2.5 feet around the headwall.

View of the outlet from the downstream bank

- Because SA6-S04 is located in an area not planned for dewatering, a cofferdam is not anticipated to be required. To prevent undermining of the outlet, avoid sediment removal in the immediate area of the outlet, leaving approximately 4 feet of clearance.

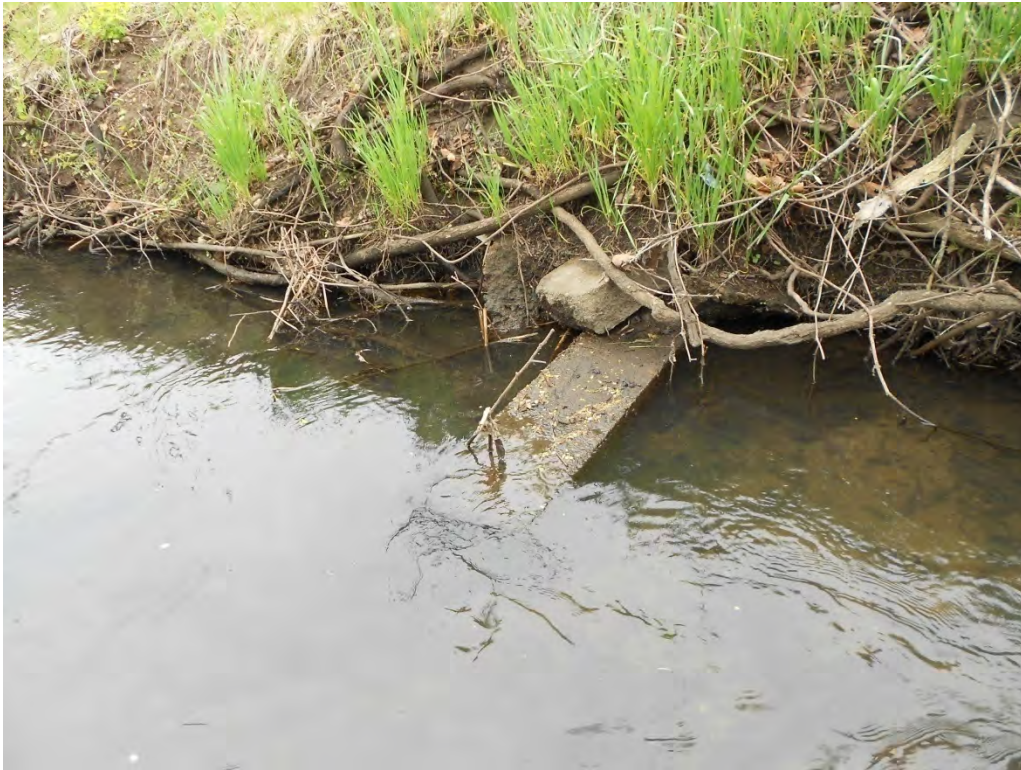
- The concrete wall has shallow surface scaling.
- The bank has minor erosion around the wall.

View of the wall from the channel

- It is recommended that the City of Kalamazoo be contacted to confirm that the wall can be removed in conjunction with sediment removal and the area restored.

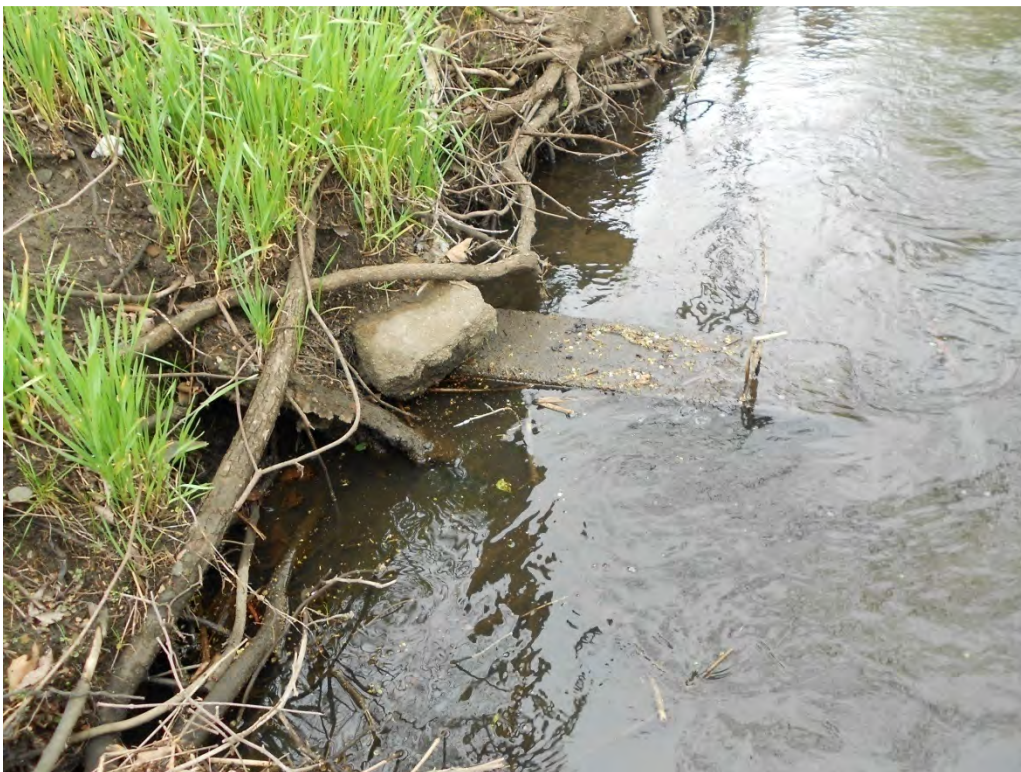
View of the wall from the upstream bank

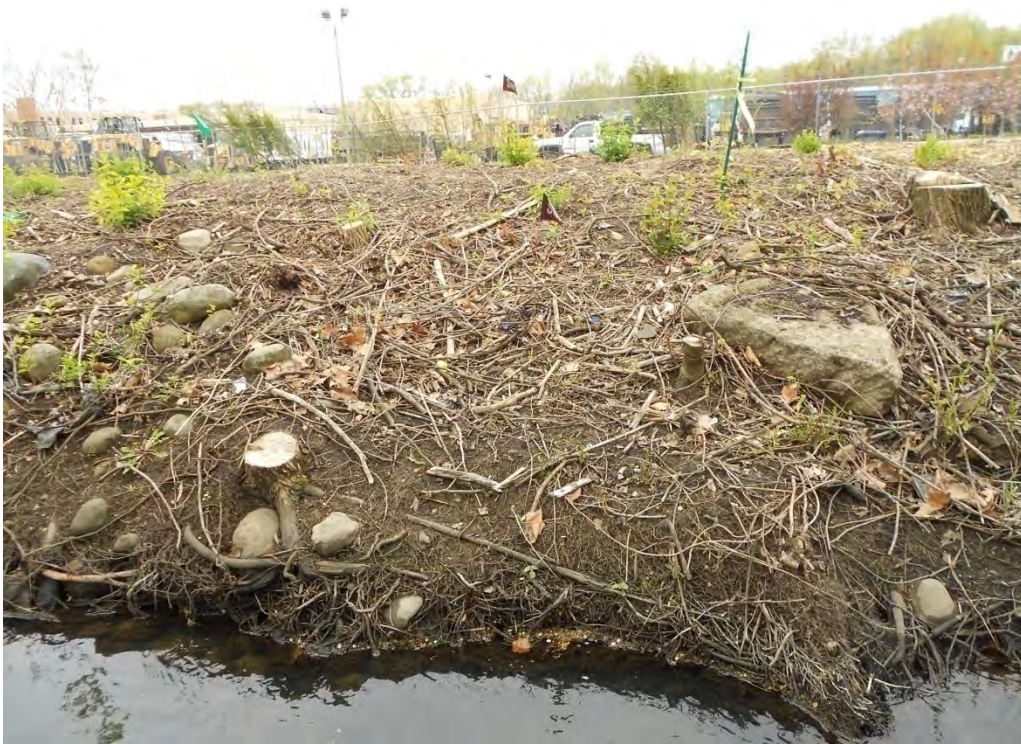
Location flagging on the west bank at the crossing

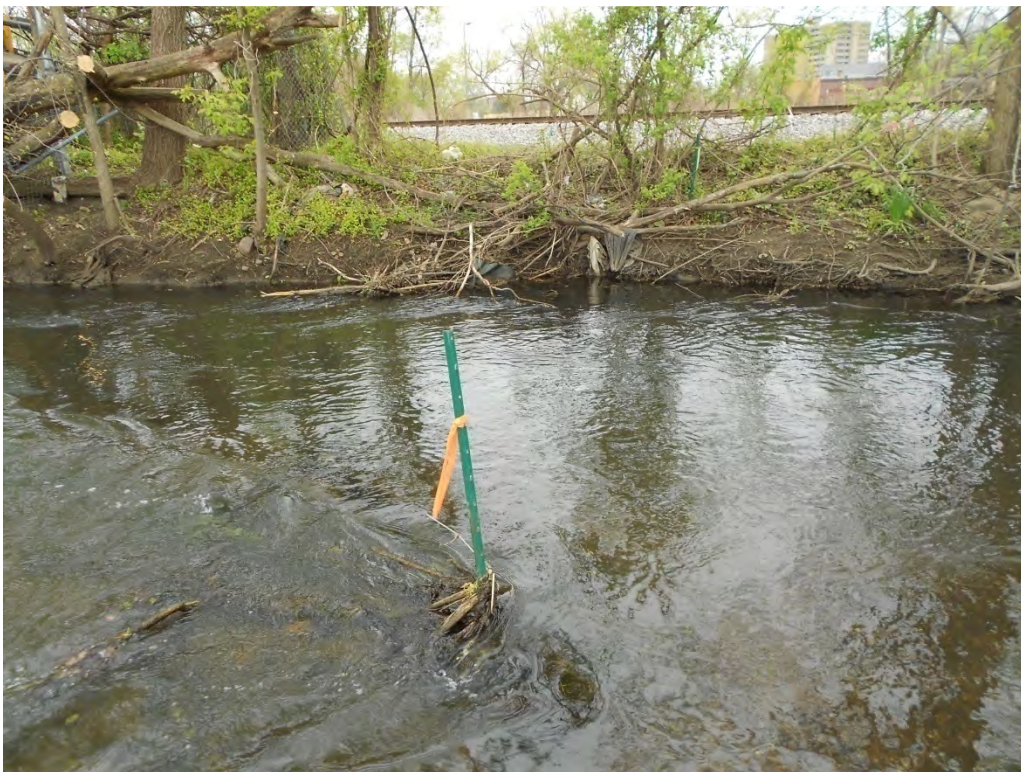
The east bank at the crossing viewed from the channel

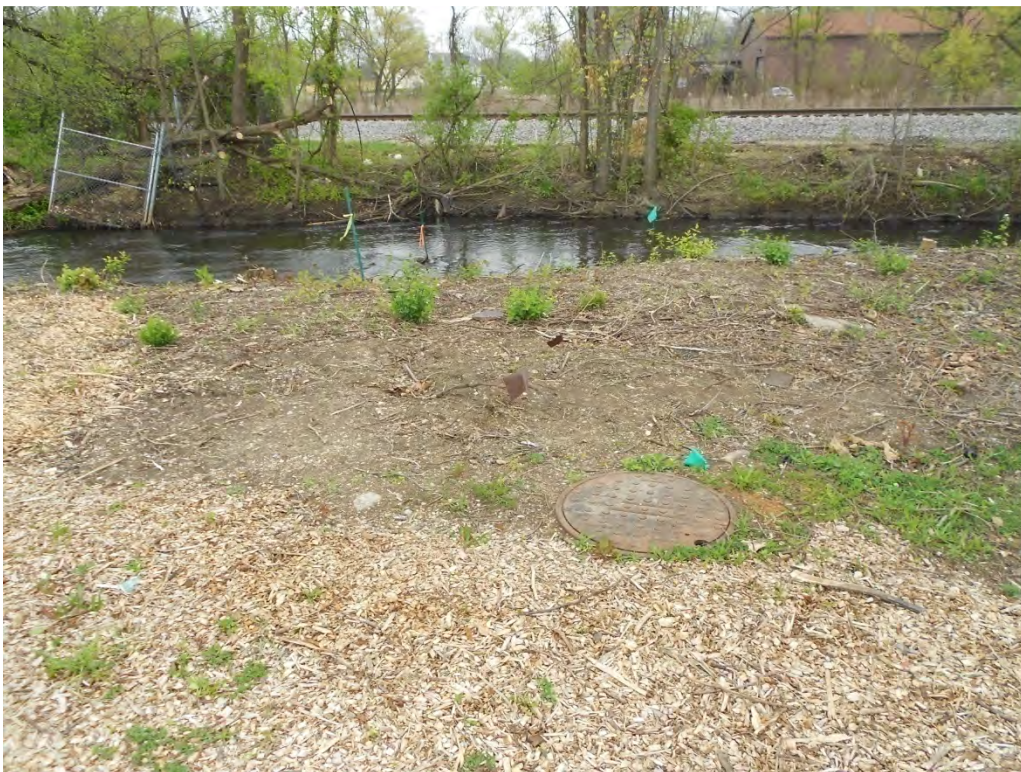
Sanitary manhole on the west side of the crossing

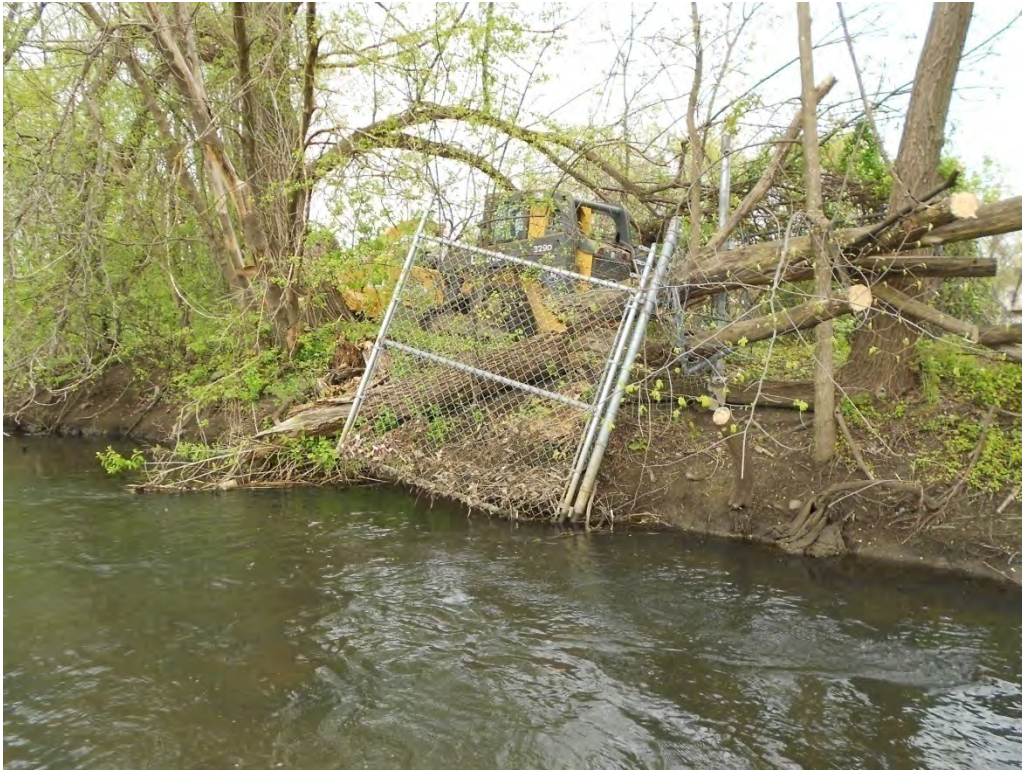
- At the time of the Pre-Sediment Removal Structure Feature Assessment, the fence was partially removed. The section in the channel area was leaning severely and not anchored on the channel side.

View of the fence from the channel

- From the technical memorandum, we understand this fence is to be removed prior to sediment removal operations and replaced in kind.

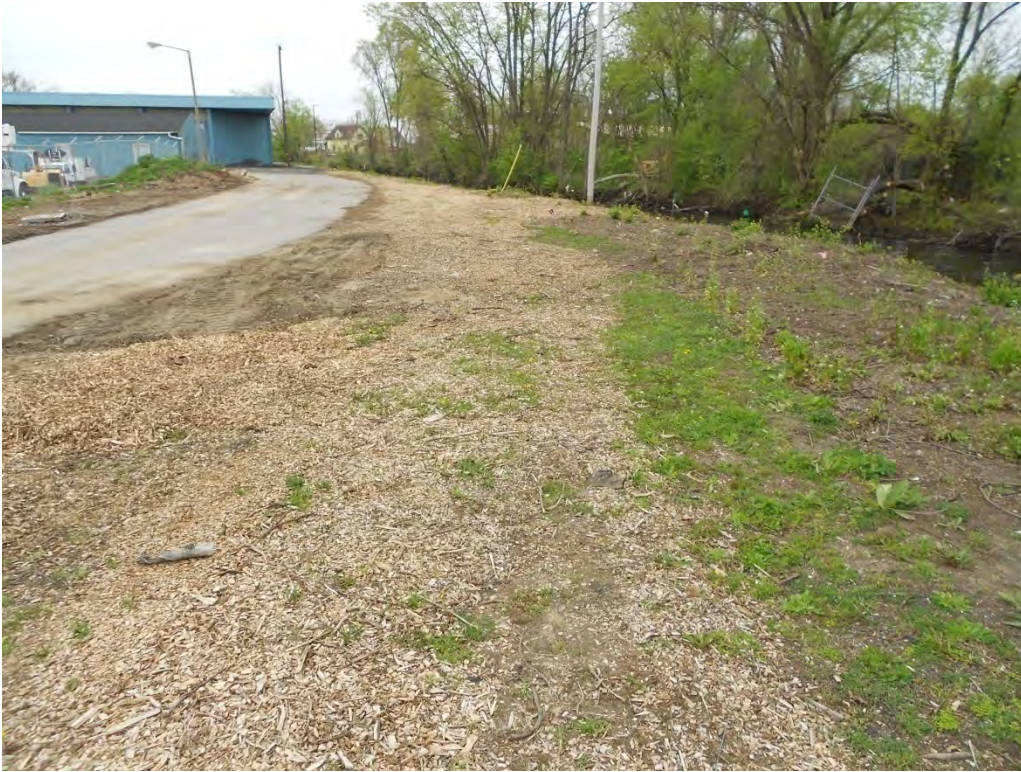
- The utility pole has a slight easterly lean, but otherwise appears to be in fair condition.

Pole and guy area viewed from the west bank

- The pole and guy should be protected from damage during excavation operations by installing construction fencing around them or other means to make operators and drivers aware of their location.
- Excavation should be avoided within a 1:1 projection of the surface at the pole and guy to avoid compromising their support. Based on their location relative to the channel, it does not appear that this will dramatically restrict sediment removal in the area.

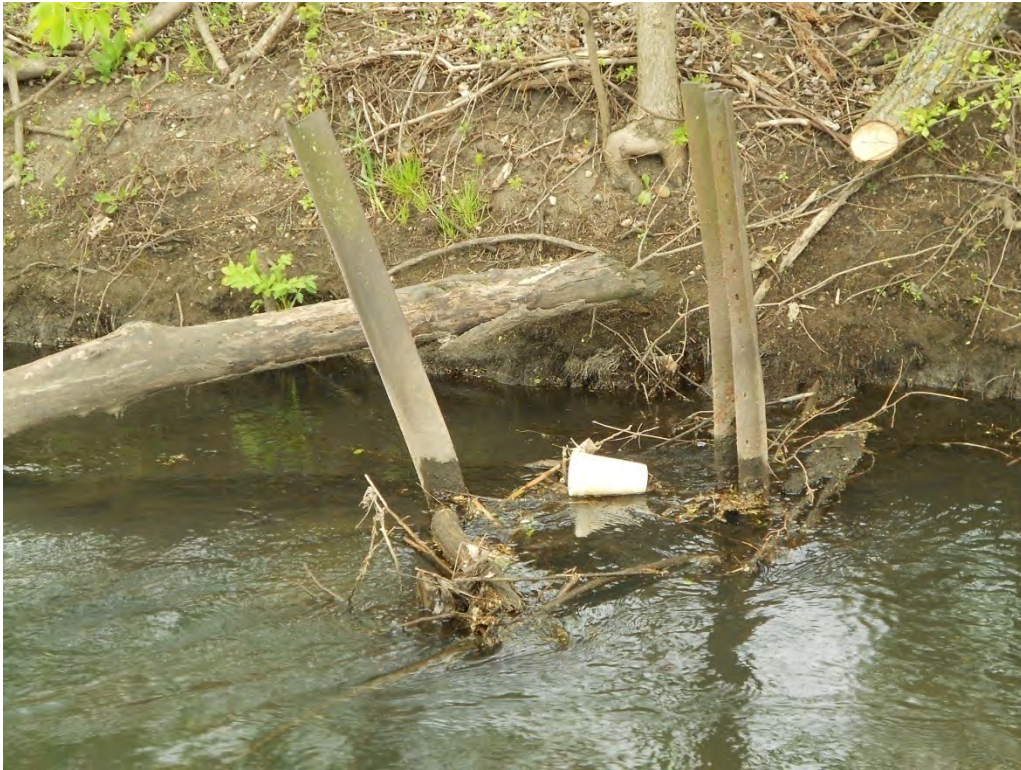
- The surface of the sections has moderate surface corrosion and both are bent in the downstream direction, likely due to impact from channel debris.

Steel posts viewed from the channel area

- It is recommended that the City of Kalamazoo be contacted to confirm that the posts can be removed in conjunction with sediment removal.
